ASIA **TURBOMACHINERY** & **PUMP** SYMPOSIUM
MARCH 2018 | SUNTEC SINGAPORE

VIBRATION ANALYSIS OF GAS TURBINE'S TRANSPORTATION CARRIGAGE AND WARRANTY ISSUES

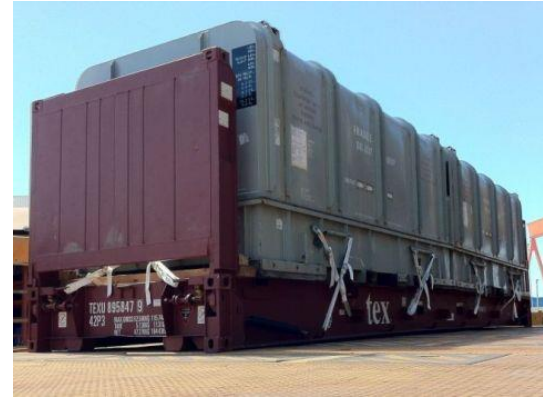
Warranty issues due to contrariety of OEMs transport requests

- A large Brazilian petrochemical company acquired 2 new gas turbines of 24MW power output.
- Transport between the port of delivery and the installation shipyard were carried out in one vehicle with multi type leaf spring conventional suspensions
- ❖ The procedure required the turbine should be housed for transportation in an appropriate Engine Shipping Containers, and that ground transportation must be performed on fully air-suspended vehicles/carriages.

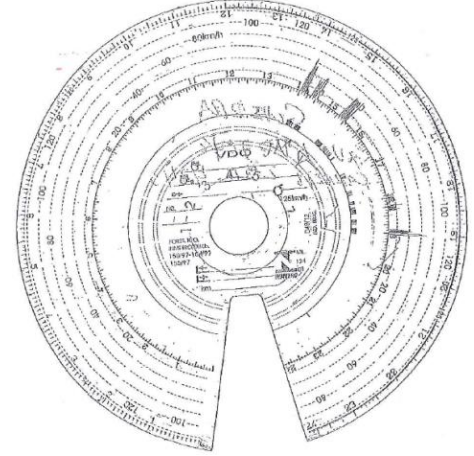
Boundary conditions (Truck)

- ✓ Same driver
- ✓ Same truck
- ✓ Same route
- ✓ Same time of the day
- ✓ Same speeds (Follow tacograph disk records)

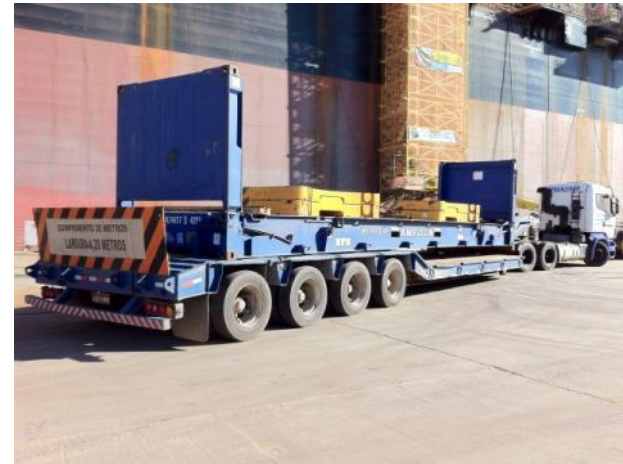
Boundary conditions (Load)

- ✓ Same equivalente mass counterweights
- ✓ Same center of gravity alocation of cargo

Mass turbine+container: 11,000 kg

Total mass (02 units): 22,000 kg

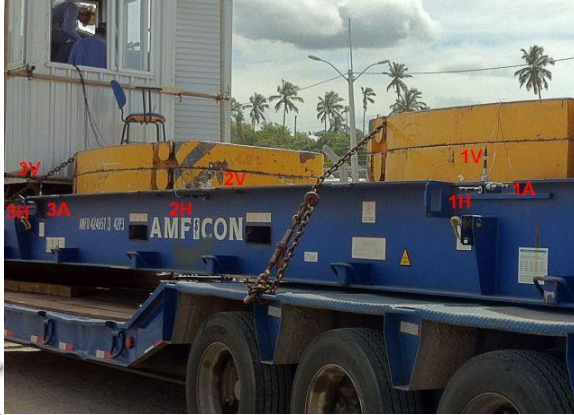
Test set-ups – Sensors placed on truck carriage structure

- Frequency scale background: 1000 Hz
- Number of spectral lines: 3200
- Acquisition time: 3.2 seconds
- Sample rate: 2560 samples / second
- Cut-off frequency high pass: 0.1 Hz

Analyzer Channel	Sensor	Measured Parameter	Measurement Point
1	1H-D	Vibration Acceleration	Point 1 Horiz. right side
2	1V-D	Vibration Acceleration	Point 1 Vert. right side
3	1A-D	Vibration Acceleration	Point 1 Axial right side
4	1H-E	Vibration Acceleration	Point 1 Horiz. left side
5	1V-E	Vibration Acceleration	Point 1 Vert. left side
6	2H-D	Vibration Acceleration	Point 2 Horiz. right side
7	2V-D	Vibration Acceleration	Point 2 Vert. right side
8	2H-E	Vibration Acceleration	Point 2 Horiz. left side
9	2V-E	Vibration Acceleration	Point 2 Vert. left side
10	3H-D	Vibration Acceleration	Point 3 Horiz. right side
11	3V-D	Vibration Acceleration	Point 3 Vert. right side
12	3A-D	Vibration Acceleration	Point 3 Axial right side

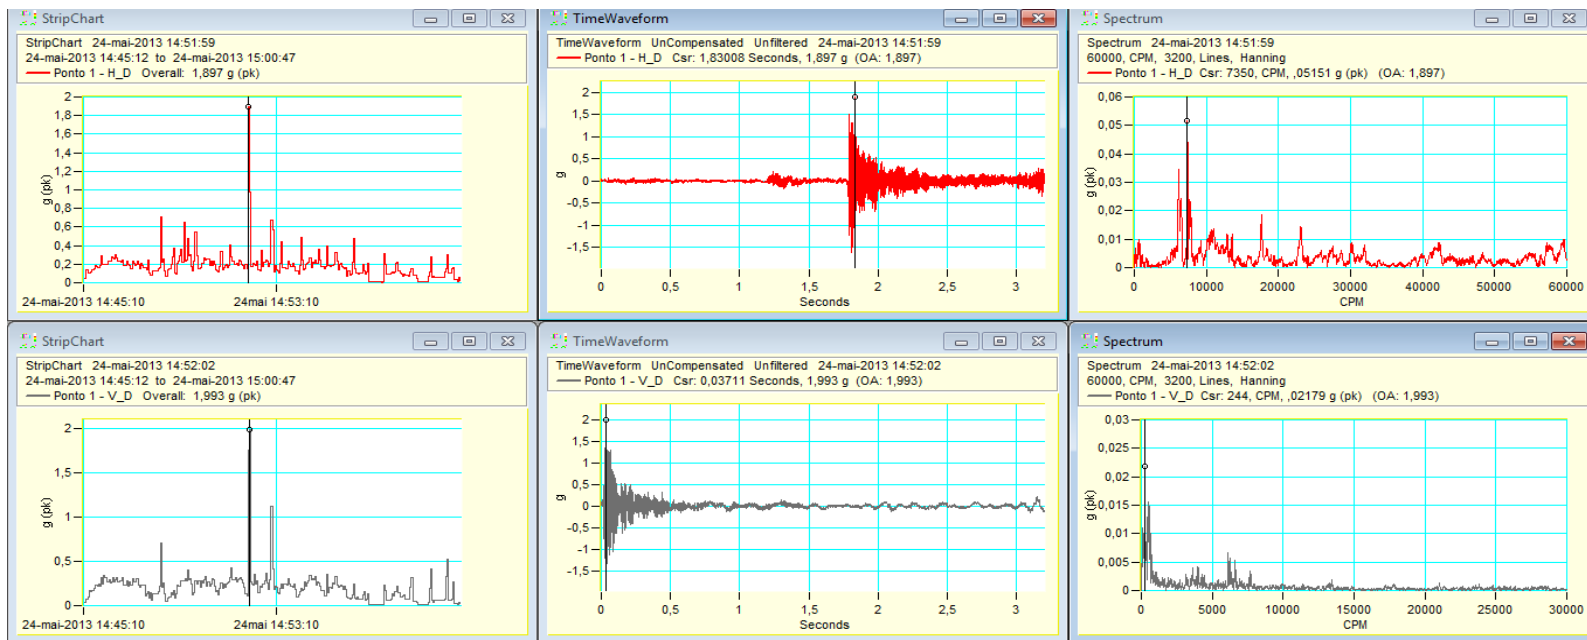
Trends, waveforms and spectra of the vibration acceleration of the truck container during tested route, with frequency range of 1000 Hz. Maximum amplitude on points 1HD 1.90 g-pk and 1VD 1.99 g-pk.

- ✓ Vibration acceleration levels during transport simulations of the containers exceeded the limits established by the OEM, but this was only true for 1000Hz frequency range measurements;
- ✓ For measurements with 200 Hz frequency range, all measurements were well below the limits recommended by the OEM.
